2006 KIHOLO BAY, HAWAII EARTHQUAKE

RMS EVENT REPORT

Risk Management Solutions

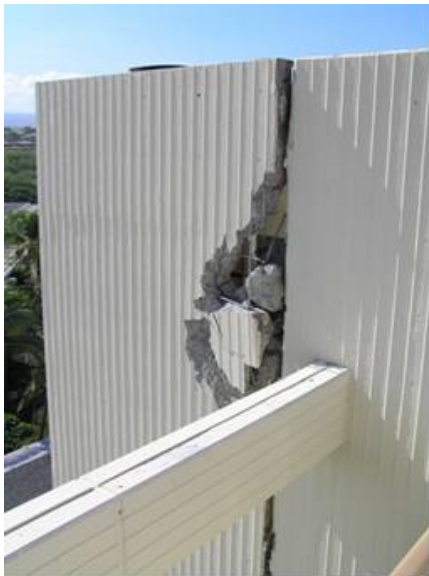
Of the resort complexes that the reconnaissance team visited, the Mauna Kea Beach Resort on the Kohala Coast sustained the worst damage, as illustrated in Figures 5a and 5b below. A few days following the event, the team was able to document several locations in various stages of clean up and repair. The worst areas were found in the corner rooms on the top floor, indicative of the high accelerations of the ground motion. Overall observations included destroyed ceiling panels, shattered windows and glass doors, exposed wall and ceiling framing, and water damage from sprinkler leakage. The most significant structural damage was caused by an elevator shaft and housing pulling away from the building (Figure 5a). Additionally, one area near an expansion joint, which allows for movement between adjoining parts of the concrete slab, had severe cracking and additional nonstructural finishing damage (Figure 5b). The damage to the ceiling and drywall was fairly major, involving significant repair costs.

Figure 5: Damage at the Mauna Kea Beach Resort: (a) structural damage at an elevator shaft and (b) severe cracking at expansion joint

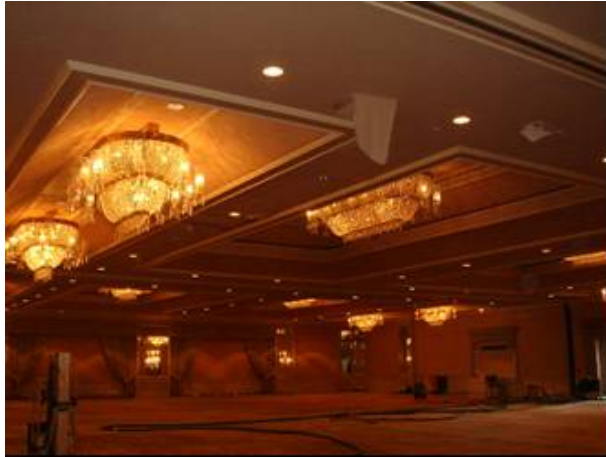
Figure 6: Clean up from earthquake sprinkler leakage (a) in the main ballroom of the Fairmont Orchid and (b) in the ballroom of the Hapuna Beach Prince Resort

At the resorts visited by the reconnaissance team, the most significant form of nonstructural and contents damage was due to EQSL, particularly noticeable in the Fairmont Orchid where the ballroom's ceiling was damaged and the floor was soaked (Figure 6a shows the clean up efforts). Additionally, the contents in a number of the rooms on the sixth floor of the south tower were damaged, as 10 to 15% of the rooms had sprinklers go off. At the Hapuna Beach Prince Resort, the head engineer also confirmed that the most serious problem had been sprinkler leakage. He reported that 40 of 48 sprinklers in the main ballroom were sheared off by the shaking ceiling panels and leaked for about ten minutes before the water supply was shut off (Figure 6b shows the clean up efforts). Interestingly, the engineer also reported that the resort has seismic shut-off values for the propane system, which performed properly.

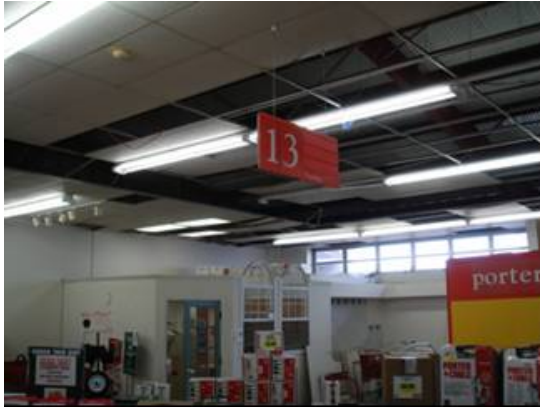
Other observed damage to commercial buildings beyond hotels and resorts included nonstructural and contents damage due to dropped ceiling panels at a hardware store (Figure 7a) and broken windows at an Airgas distribution store (Figure 7b) near Waimea. In North Kohala, a small concrete block building that housed the local Bank of Hawaii office was completely shut down. There were major cracks in the structures façade and one front window had shattered.

Figure 7: Nonstructural damage to commercial properties in the form of (a) dropped ceiling panels and (b) broken windows

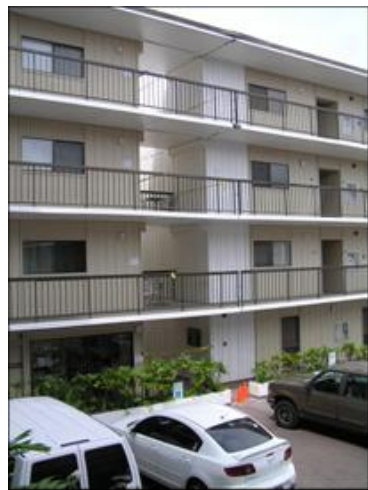
Several multi-family dwellings also experienced damage with patterns similar to those seen in other commercial structures. In particular, minor crushing at expansion joints, nonstructural damage to ceilings and partition walls, and damage to contents were commonly observed. A four-story apartment complex in Kailua Kona had damage at the balcony/breezeway joints on all levels in both wings. There was minor crushing and spalling of the concrete at the joints as well as residual gaps especially at the upper floors (Figures 8a and 8b). The facilities manager listed additional problems relating to piping, including minor sprinkler leakage limited to the underground garage, and ruptured hydraulic lines in the elevator system.

Figure 8: Damage to an apartment complex in Kailua Kona, showing (a) moderate pounding damage at breezeway joint and (b) a close-up of crushing of concrete slab and residual separation at the third and fourth levels

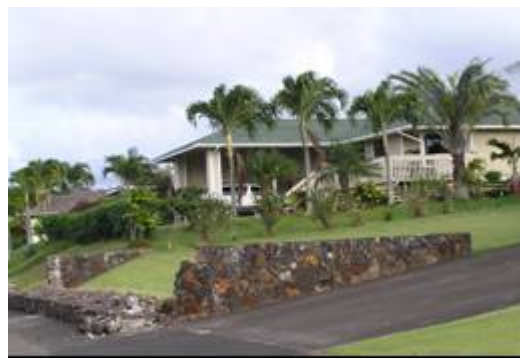
The typical Hawaiian home is wood frame construction as shown in Figure 9a, which withstood the ground motions from the Kona Earthquake fairly well. Interestingly, many of the unreinforced lava rock and rubble stone walls in front of residential homes collapsed as shown in Figure 9b, illustrating the importance of reinforcement in masonry and stone building construction.

Figure 9: (a) Typical house with no damage in Waimea and (b) collapse of a rubble stone wall in front of a home in North Kohala

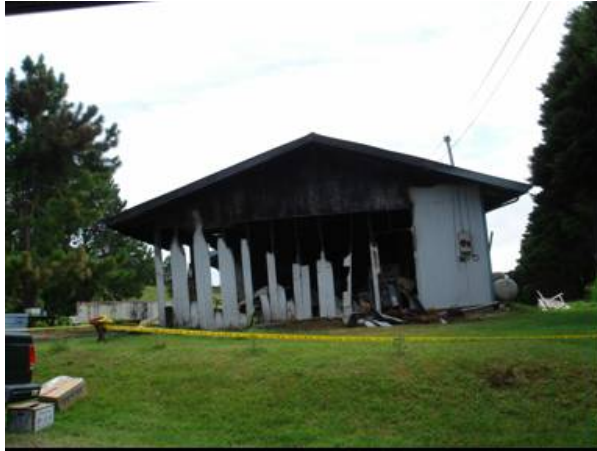
As for other contents damage, many homeowners reported 'breakage' of their personal belongings, including dishes, pictures, televisions, stereos, etc. One exception to the typical damage seen in residential properties was a house in Waimea, which was completely destroyed due to fire following earthquake (FFEQ) as shown in Figure 10. A gas leak triggered the fire.

Figure 10: House destroyed by fire following earthquake in Waimea

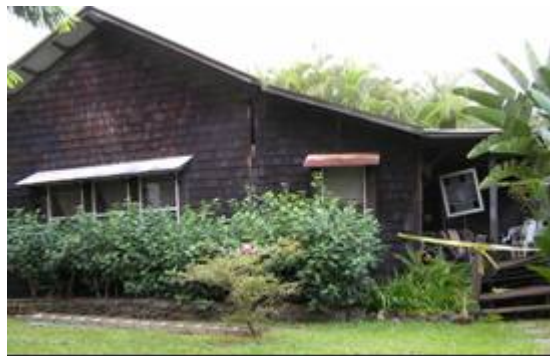
Another exception to typical damage was seen in the Kohala area, where several single-family residences with pier-and-post foundations had been structurally damaged. A pier-and-post foundation behaves similarly to a cripple wall (as seen in California construction), offering little lateral resistance to earthquake loading. This type of construction is found in some older, wood frame homes sometimes referred to as Hawaiian ‘plantation’ style. While these types of homes are highly damageable, they do not represent a significant portion of the building stock. One example is shown in Figure 11, where the wood frame house shifted off its foundation.

Figure 11: Damage to a residential structure in North Kohala, where the wood frame home shifted off its foundation

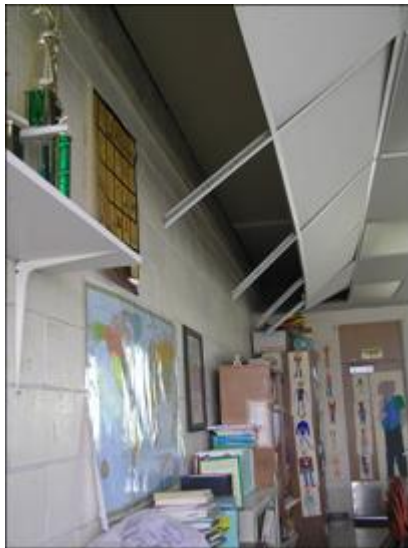
Several of the island's public school facilities temporarily closed parts of their campuses due to the ground shaking damage. In the case of Waimea Elementary School, multiple classrooms had ceiling panels along the perimeter of the room that were cracked or had completely fallen out as shown in Figure 12a. The metal hanging system for the ceiling panels were bent and had pulled the anchors out of the wall. With repairs and clean up underway in many of the classrooms, the school hoped to fully re-open within six days of the event. Similarly, Waikoloa Elementary School sustained heavy damage to the hanging ceiling system in all of its 32 classrooms as shown in Figure 12b. There was no structural damage, however; the damage estimate is approximately \$2 million for the ceiling and light fixtures. The school was expected to remain closed for a week following the event.

Figure 12: Nonstructural damage in schools, showing (a) dropped ceiling panels in a classroom at Waimea Elementary School and (b) hanging ceiling system damage in a classroom at Waikoloa Elementary School

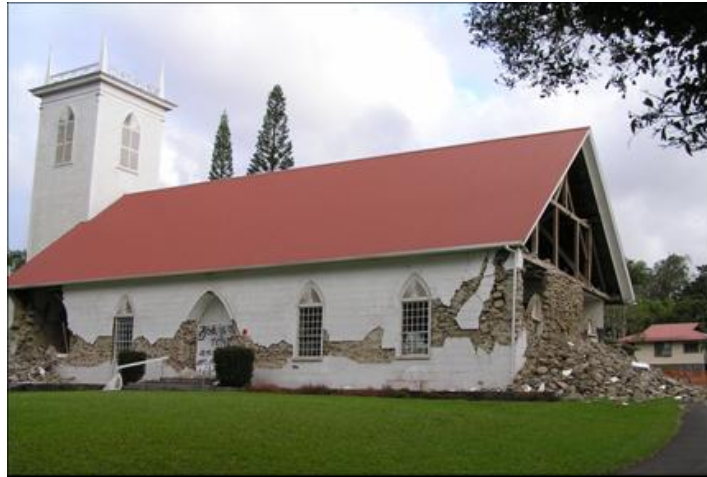
Beyond damage to public schools, there was widespread damage to old historic buildings. In particular, Kalahikiola Church in Kapaau was completely destroyed as shown in Figure 13. The Landmark Baptist church in North Kohala was also marked as unsafe and displayed major cracks in the façade.

Figure 13: Severe damage experienced at Kalahikiola Church in Kapaau

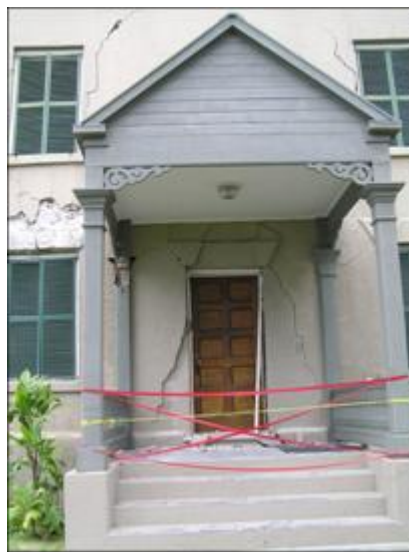
Two historic buildings in the Kailua Kona community also had significant damage and were red-tagged as unusable by officials. Although the nearly 200-year old Mokuaikaua Congregational church was visually in good shape, engineers were still in the process of assessing the stability of its lava rock and mortar construction walls less than one week following the earthquake. Just across the street, the Hulihe'e Palace suffered major external cracks on multiple walls (Figure 14). Local newspapers report that repairs are expected to cost more than \$1 million.

Figure 14: Damage to Hulihe'e Palace

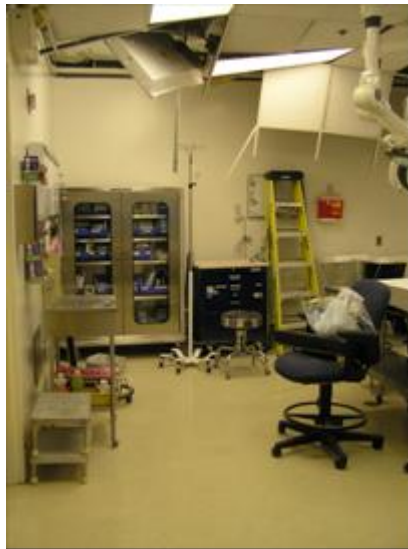
Kona Community Hospital, a 94-bed full-service acute and long term care facility, was severely impacted by nonstructural damage to ceilings and equipment (Figure 15). A major challenge was the evacuation of the hospital's long-term care patients, who were housed in a nearby hotel with their caretakers for five days. Their return to the hospital and the completion of significant repairs marked the achievement of 35% operating capacity, up from nearly 0%. The regional chief operation officer for the hospital estimated that business interruption (BI) costs are \$150,000 per day while not fully operational and that physical damage costs are around \$5 million. The hospital was expected to be 100% operational by October 27, less than two weeks after the event.

Figure 15: Non-structural damage to equipment and ceiling grids at Kona Community Hospital
