# 1953 U.K. FLOODS

50-YEAR RETROSPECTIVE

Risk Management Solutions

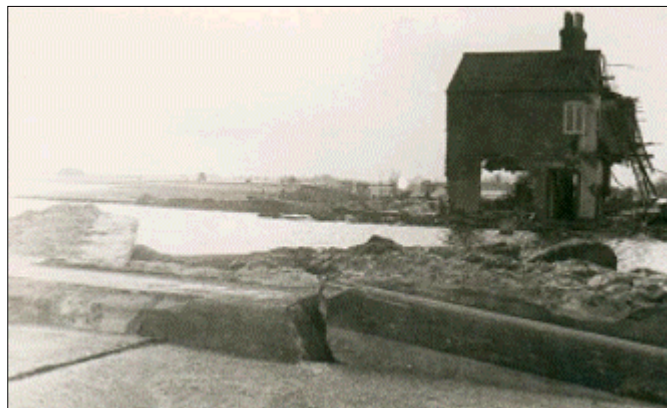
*Figure 1. Coastal flooding affected 1,600 km of the east coast of England (Courtesy Professor Wolf)*

A government inquiry into the causes of the floods identified that along the 1,600 km (1,000 miles) of east coast affected there were 1,200 flood defence breaches, 647 square kilometers (160,000 acres) of land flooded, 307 people died and 24,000 houses were damaged, of which 500 were totally destroyed. Around 200 industrial facilities were also damaged by floodwater. On the positive side, over 32,000 people were safely evacuated. A massive military assistance exercise was immediately mobilised to rescue inhabitants from the floodwaters, and to temporarily repair and stabilise the damaged defences. At the peak of the exercise on 12 February, 30,000 emergency workers were operating.

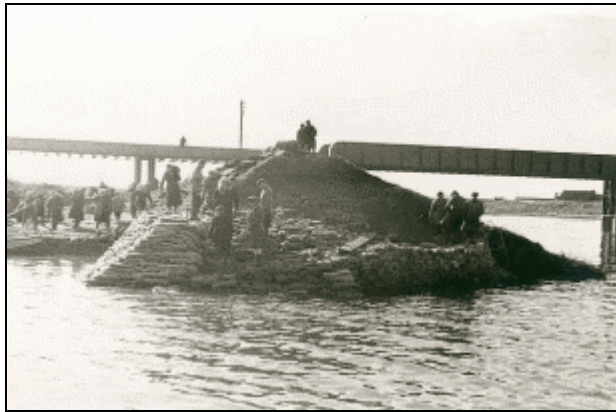
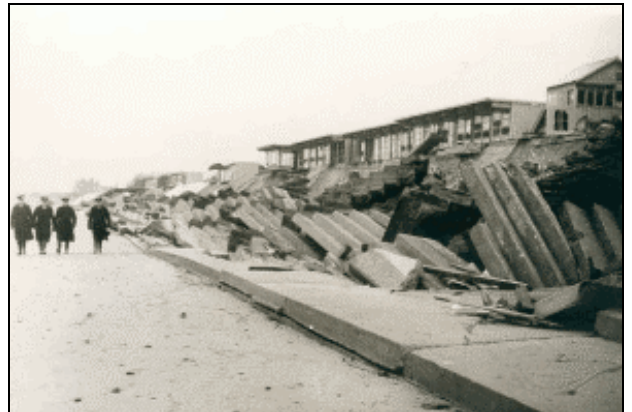
The high water levels associated with the combination of storm surge and tide had not been foreseen in the design of coastal flood defences, which were unable to hold back the water in many places. Several mechanisms contributed to the defences' failure. In some cases the powerful surge and associated waves scoured the seaward face of the defences while water that had overtopped or flowed through cracks and permeable layers eroded the inland face, leading to damage and collapse. Elsewhere, sand and earth fillings were washed out, undermining the embankments and again leading to collapse. At a number of locations properties were subjected to the repeated entry of the tides for days and weeks as seawater continued to flow through the breaches. However the huge repair and recovery operation meant that around 90% of the breaches in England were closed within a month. Photographs taken shortly after the disaster by Professor P. Wolf during a survey of the coastal defences in Lincolnshire and Norfolk reveal the extent and nature of the damage.

*Figure 4. Hard engineered walls and concrete defences were severely damaged by the pounding waves (Courtesy Professor Wolf)*

The catastrophe revealed the inadequacy of coastal defences then in place and led to Britain's largest sea defence improvement program. All the damaged defences were repaired temporarily in the weeks immediately following the floods, before permanent renovation. In the following years, defences were raised by up to 2 m (6.5 feet) and strengthened around the principle concentrations of population and exposure to protect against storm surges with a return period of up to 1 in 1,000 years. The spectre of a major storm surge flood in London led to the construction of the Thames Flood Barrier near Woolwich, which became operational in 1982. The barrier was initially designed to protect against extreme tidal surge events with a return period of up to 1 in 1,000 years until 2030. In addition, the Storm Tide Warning Service, a national flood-warning organisation, was created to improve the accuracy and efficiency of coastal surge warnings to the public as well as the authorities. As part of this effort, a network of tidal gauges was installed around the British Isles coastline to provide accurate water height measurements and connect weather forecasts with tidal movements.

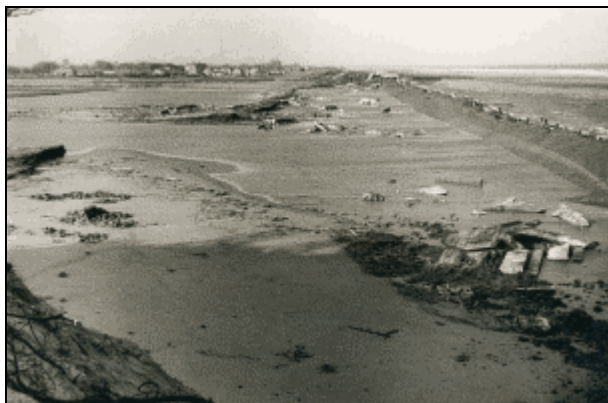
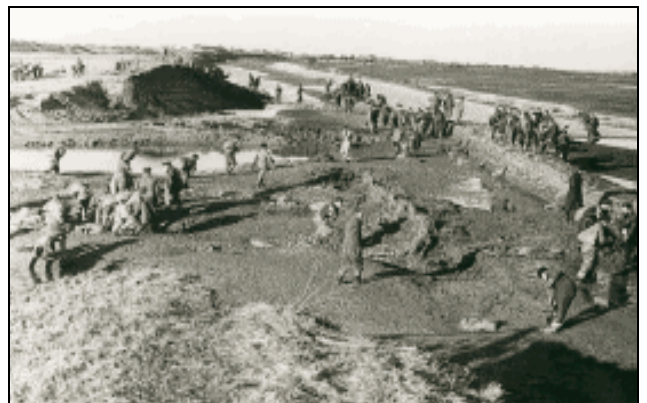
*Figure 5. Seawater washed over and broke through walls and earth dikes (Courtesy Professor Wolf)*

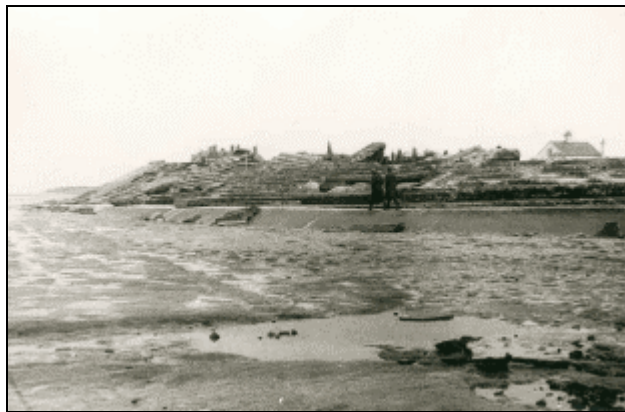
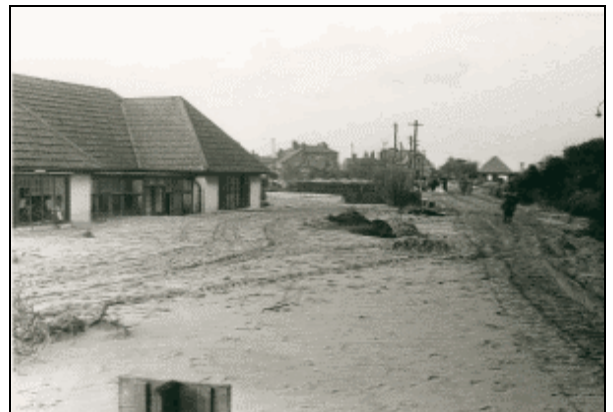
*Figure 6. Sand was washed from beaches revealing the underlying clay as on the left hand side and transported inland where it half buried properties such as the bungalow on the right hand side (Courtesy Professor Wolf)*
