CYCLONE TRACY 30-YEAR RETROSPECTIVE

Risk Management Solutions

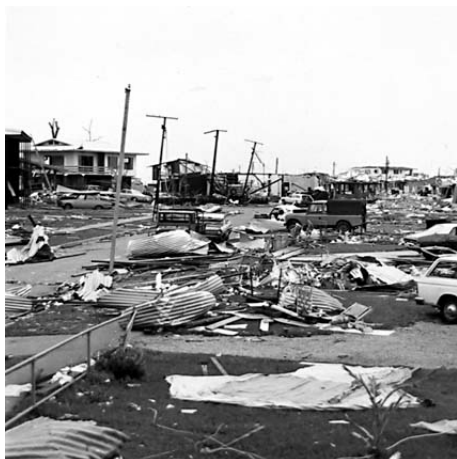
Figure 2: Damage from Cyclone Tracy in the residential neighborhood of Amsterdam Circuit (National Archives of Australia (NAA))

Tracy was one of the worst natural catastrophes in Australian history. In 1974, Darwin had about 40,000 residents – about half of the Northern Territory population – and Tracy’s official death toll reached 45 in Darwin with another 16 deaths at sea; 500 people were injured. But, the legendary nature of Tracy came from its structural devastation. About 60% of the 8,000 houses in Darwin were destroyed, and more than 30% were severely damaged. Only 6% of Darwin’s housing stock survived with anything less than minor damage. In the northern suburbs of Darwin, close to 100% of all residential properties were ruined.

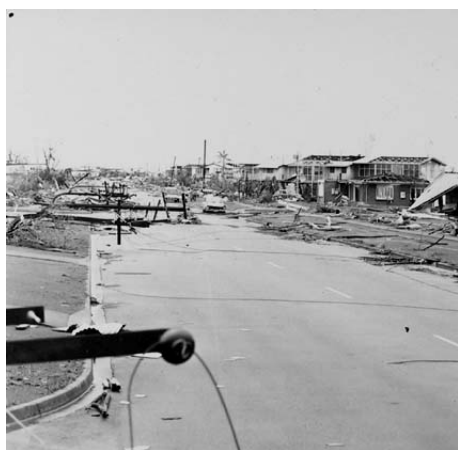
Figure 3: Modern residential neighborhood damage Ross St., Darwin (NAA)

Post-war housing expansion in Darwin had been rapid since the mid 1950s, and it was the housing sector that took the brunt of the storm. In particular, fewer than 5% of the houses in the newer suburbs, built since the mid 1950s, survived. Although the pressure that Tracy's winds exerted on structures was within structural engineering design codes at the time, these codes were not usually applied to housing – they were mainly applied to engineered commercial buildings – leaving the residential building stock extremely vulnerable.

The investigative team discovered three factors that accounted for most of the damage: fatigue failures of cladding fasteners, internal pressures that were not allowed for in design, and lack of design for horizontal forces. Racking failures occurred because the walls did not adequately resist horizontal forces, due to the fact that neither the external wall cladding (typically fibro) nor the internal wall lining was securely fastened to the frame of the structure. The walls tended to “rack” or become unstable when they could not resist the shear forces. Lessons from Cyclone Althea, that struck Townsville three years earlier, had been incorporated into the newest buildings constructed in Darwin. Roof cladding had been tested to twice its working load but the testing had been done for static loads. Initial tests after Tracy showed that under fluctuating loading, such as what occurred during Tracy, the strength of the fastening systems was reduced significantly (to less than

15% of the original strength under static loads). In addition, broken windows, particularly on the windward side, caused greater internal wind pressures than assumed in the design with particularly severe consequences for roof tie-downs.

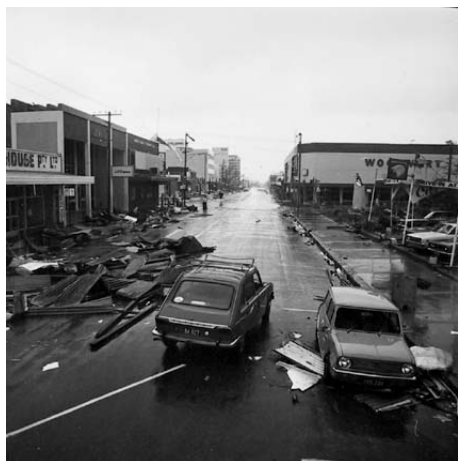
Figure 4: Damage to Smith St., Darwin (NAA)
