CENTRAL EUROPE FLOODING, AUGUST 2002

EVENT REPORT

Risk Management Solutions

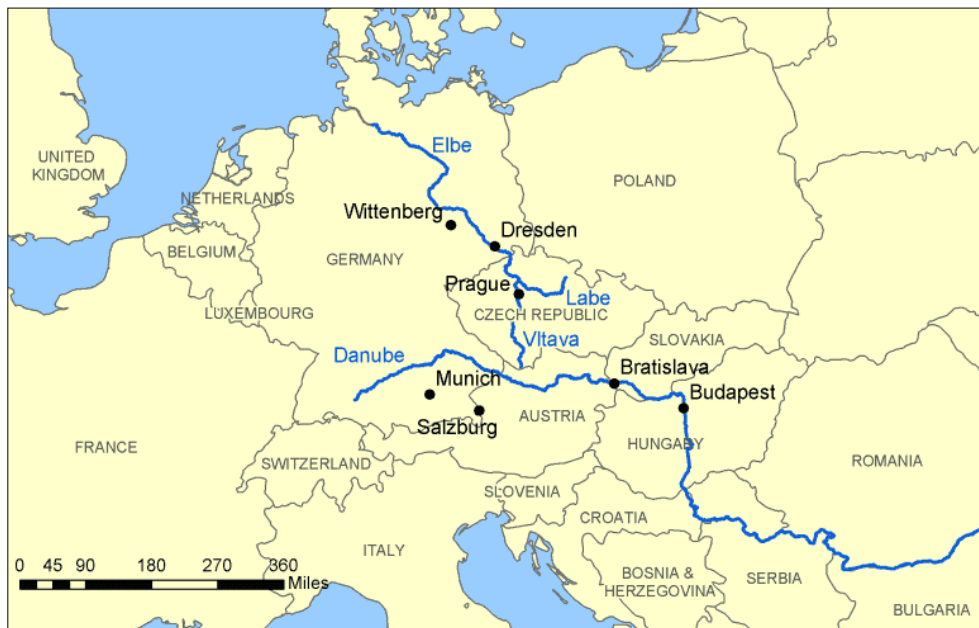
Figure 1. Major rivers and cities affected by the August 2002 floods

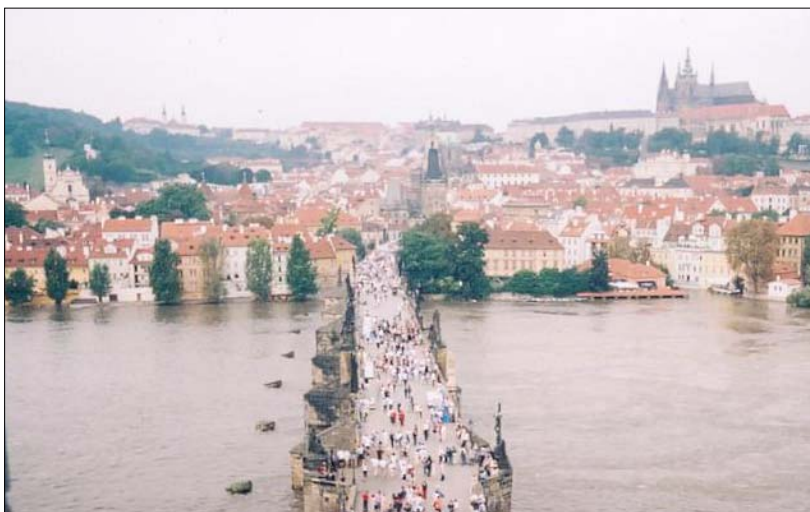
Figure 3. River Vltava in Prague on August 10 after the arrival of water from upstream rains on August 6 and 7

Although this initial phase of rain produced some localized flooding, much of the water runoff was contained by a series of reservoirs (known as the Vltava Cascade) upstream of Prague. Water was gradually released from the dams over the following days, but the increased capacity was insufficient to prevent the flood wave that followed less than a week later.

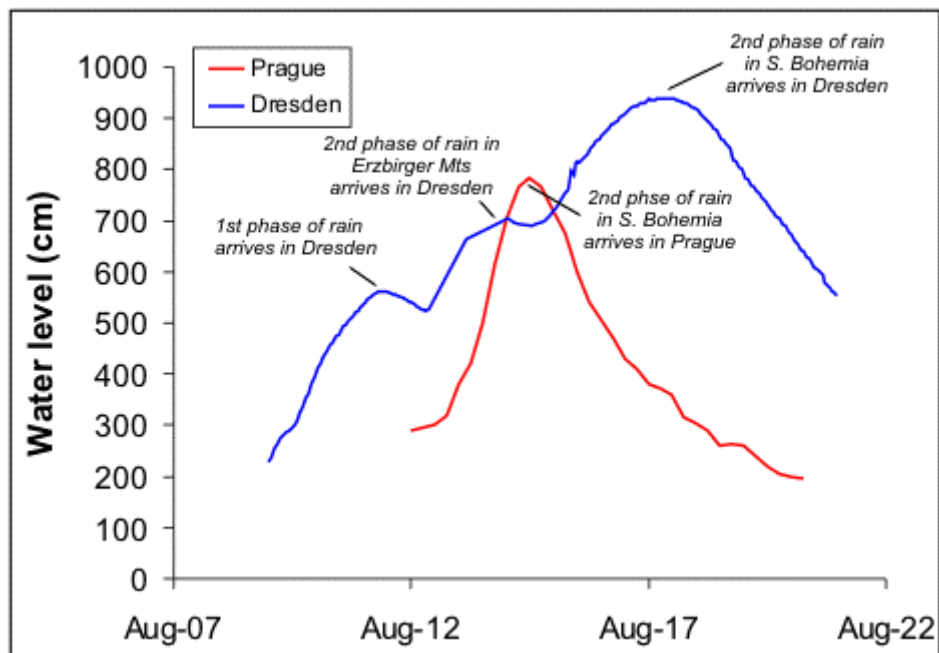
Figure 7: River heights in Dresden and Prague during August

At the same time, the Vltava flood wave overtopped reservoirs and rapidly progressed downstream to Prague. The flood wave combined with another wave entering the basin from the River Berounka, just south of Prague, to create an unprecedented river discharge of 5,300 cubic meters per second (187,200 cubic feet per second) in Prague on Wednesday, August 14 (Figure 6). The CHMI estimate a discharge of this magnitude has a 500-year return period. At the beginning of the month before the rain, discharge was recorded at 400 cubic meters per second (14,130 cubic feet per second). River gauge records show the rapid onset of the flood in Prague (Figure 7).

The flood wave continued down the Vltava into the River Labe (known as the Elbe once it crosses the Czech/German border) and into Germany. On the morning of Saturday, August 17, the river level in Dresden peaked at a record height of 9.4 m (30 feet), superseding the previous record of 8.8 m (29 feet) set in 1845. The increase in river height in Dresden was more gradual and of greater magnitude than the flood peak in Prague. The 160-km (100-mile) progression of the flood wave from Prague to Dresden spanned three days. In total, the flood wave took around 12 days to travel from the upper reaches of the Vltava to the mouth of the Elbe in northern Germany, a distance of over 1,000 km (620 miles).

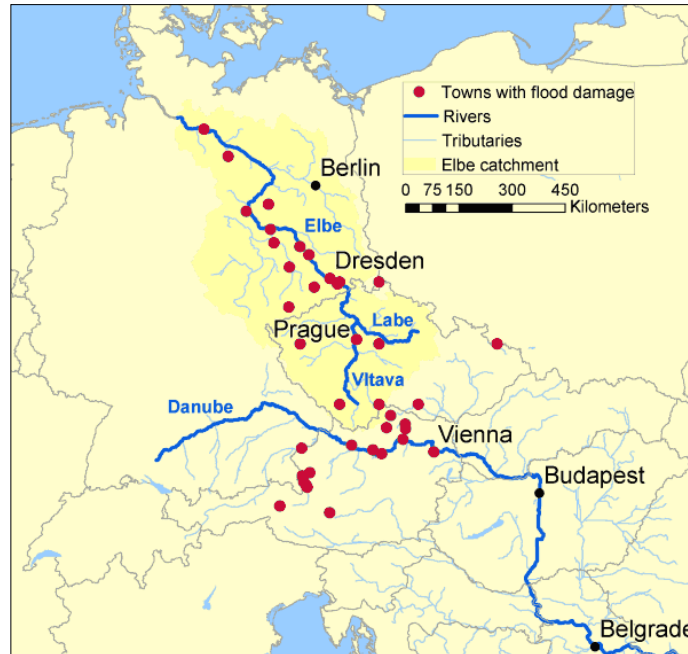
Figure 8. Overview of rivers and towns affected

Most of the loss (over 11 billion Euro) came from the River Elbe catchment, which covers 64% of the Czech Republic and 27% of Germany. A further 2 billion Euro damage was caused in Austria. Key contributors to the large loss were damages in Prague, Dresden in the state of Saxony, and Germany (Figure 8). Saxony and Prague together sustained over 7 billion Euro of damage.

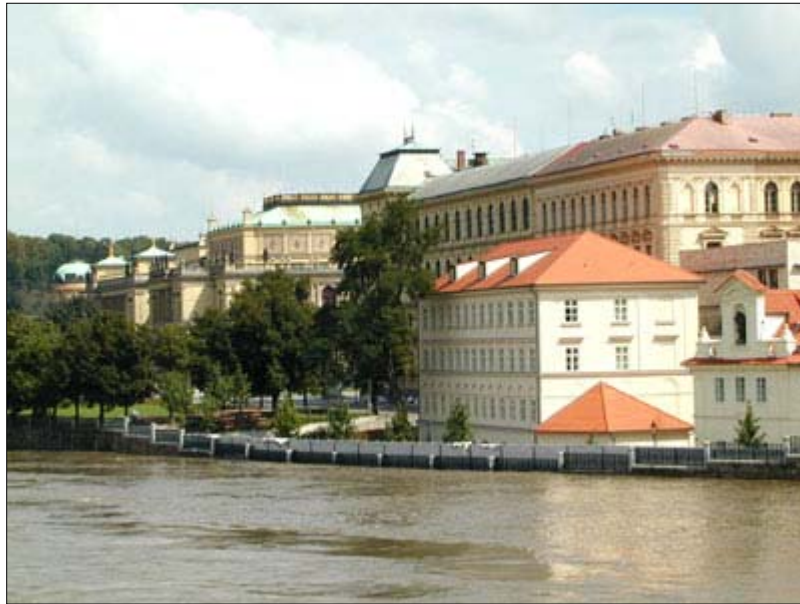
As warnings of the impending flood were issued, city officials implemented Prague's flood protection plan and erected a temporary barrier along the Vltava's right bank, protecting most of the Old Town. Figure 10 shows the barrier protecting the Four Seasons Hotel and surrounding properties. Prague financed the barrier following severe flooding in 1997. The barrier is made up of 3 m (10 feet) long aluminum bars stacked horizontally in-between support posts that are dropped into pre-sunken holes 6 m (20 feet) deep.

Figure 11. View toward the Old Town showing the temporary flood barrier in front of The Four Seasons Hotel

The barrier was effective in preventing the river water from inundating the streets of Old Town and Josefov, but some property extends out into the river, and remained exposed to flooding. This area (visible in Figure 11) is the inundated area opposite Kampa Island. The barrier was located to the east of these properties, allowing water to run up the south face of the buildings and flow through the ground floors, exiting the rear of the buildings immediately to the south of the Charles Bridge.

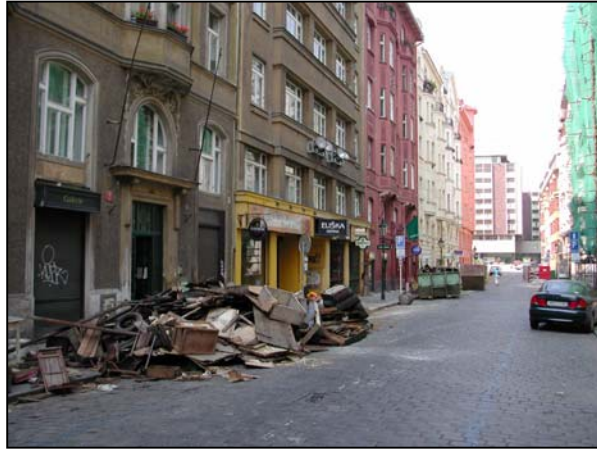
The amount of underground flooding in Old Town and Josefov suggest that the city's age played a role in the observed flood damages. Basements in this area are commonly used as residences, businesses and for storage. The contents and interior spaces of many flooded basements were heavily damaged (Figure 12). Site-specific structural surveys were required at many locations to ensure buildings were sound before standing water could be pumped out, as the high external water pressure could cause walls to collapse inwards. Vents to basements of many businesses and homes in the district were left open for several weeks to assist evaporation of the water.

Figure 12. Piles of damaged contents lay in the streets

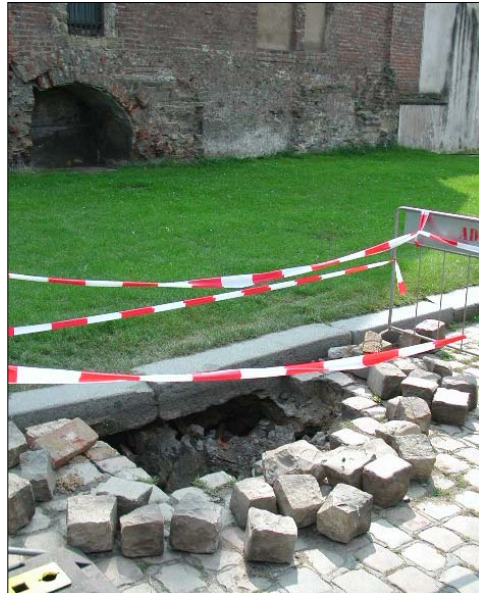
The seeping waters also heavily damaged Prague and Karlin's utility infrastructure (Figure 13). Gas service to central Prague was cut while workers repaired the damaged equipment and pipes. Electricity was restored to most areas in mid-September, gas in October, and telephone services in November. Some areas, however, were without a fully functioning heating service for several months. Many buildings within these areas were unusable during this time, and for the others the use of portable dehumidifiers and heaters increased business interruption costs. There were also many reported instances of roads cracks and pavements buckling. Warmer weather in spring and summer 2003 may cause more cracks and holes as the earth and buildings begin to expand again after the cold winter.

Figure 13. Repairs to below ground infrastructure were visible throughout the Old Town

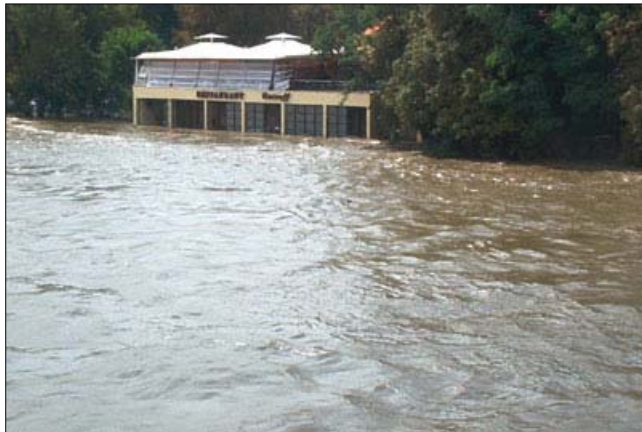
The river water submerged islands south of the Charles Bridge, which connects the Old Town to Kampa Island in Lesser Town. Buildings on these islands had visible water marks on the outside, clearly indicating the depth of flooding. There was a notably high quality of construction of the properties on these islands, particularly relative to some of those observed in the Karlin District. Although directly impacted, the restaurant in Figure 14 survived the direct force of the river's current on its south facing wall, as well as impacts from waterborne debris. On the contrary, collapsed buildings in Karlin were located much further inland and far from the water's strongest currents.

Figure 14. This restaurant on an island south of Legions Bridge survived the flood structurally sound (left picture courtesy of Radio Prague)

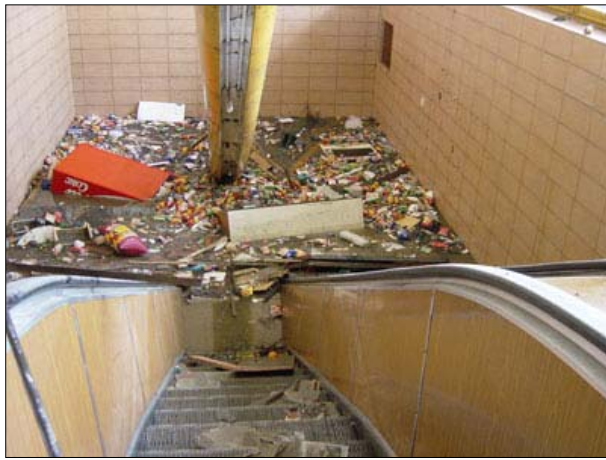
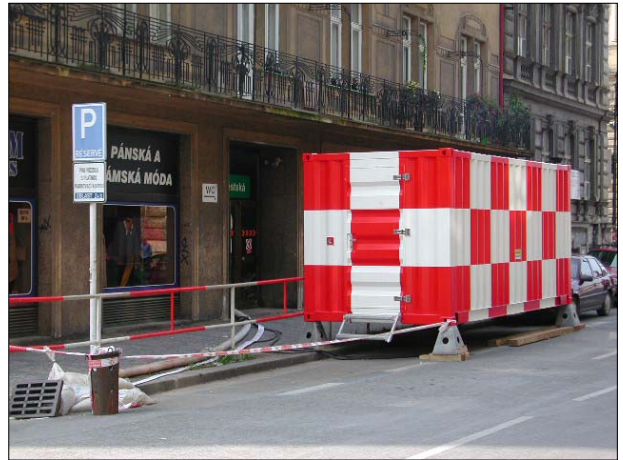
Prague's Metro is a modern, below-ground electric mass transit system. Flooding closed thirteen stations and the associated connecting lines (bold dashed lines in Figure 10). Repairs continued for at least 6 months, at an estimated cost of 230 million Euro (Figure 15). There were several methods of water entry that caused the inundation of a large section of the system. Five stations flooded as water poured in from the street. Water leaked into others through poorly sealed electrical cables, which extend through stations and tunnels up to the surface.

Although refuted, the local 9olice reported that some of the heavy doors leading into the stations from outside, as well as pressure-sealed doors that isolated stations from the tunnels, were not closed properly. The pressure-sealed doors were designed to keep gases (rather than water) out, in the event of military attacks; the mechanism for closing them is complicated. Water was also forced into the tunnels by the high water pressure underground. Under normal conditions up to 4,000 cubic meters (140,000 cubic feet) of water has to be pumped from the network each day because of water ingress. Poor quality construction and repair work has also been identified as a possible cause of breakages in the tunnel walls.

Figure 15. Flooding of the Florenc Metro station (left; courtesy Radio Prague) and removal of water at the Staroměstská Metro station (shown on right)

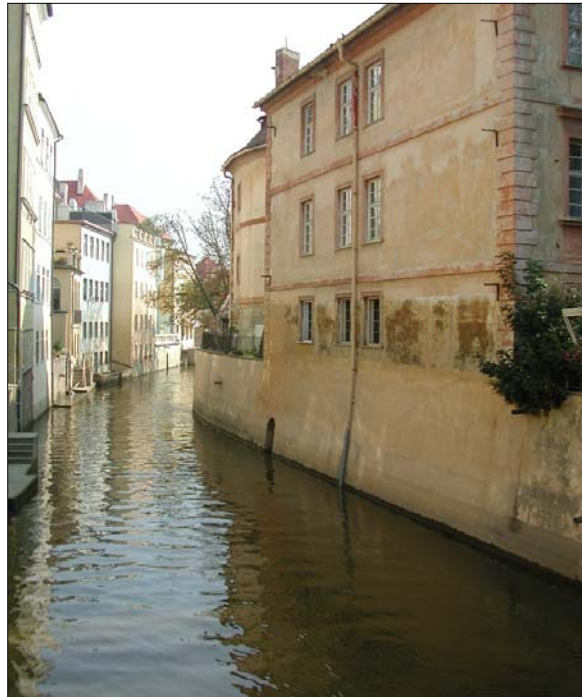
Lesser Town (shown as survey area 2 on Figure 10) is a historic district on the left bank of the Vltava. The district is bounded to the west by the steep hill of Prague Castle, which limits the area at risk from flooding to a 300 to 500 meter zone (984 to 1640 feet). Many of the buildings date from the 17th and 18th century, with some built as long ago as the 13th century when the district was first settled. This high-risk flood zone includes Kampa Island, separated from the rest of Lesser Town by Certovka Creek. Although proposals have been made in the past, a floodgate was not installed on the Certovka Creek to protect Kampa because local officials feared that it might depreciate the historic nature of the surroundings. In August, sandbags were employed along the riverbank, but were overwhelmed by the volume of water. As a result, the water depth reached over 4 meters (13 feet), causing near complete content losses in the ground floor of structures in this area and prolonged business disruption. However, despite its direct exposure to the river's current, there were no structural failures in this area.

Figure 16. Water marks are clearly visible on the outside of this building on Certovka Creek, immediately west of Kampa Island

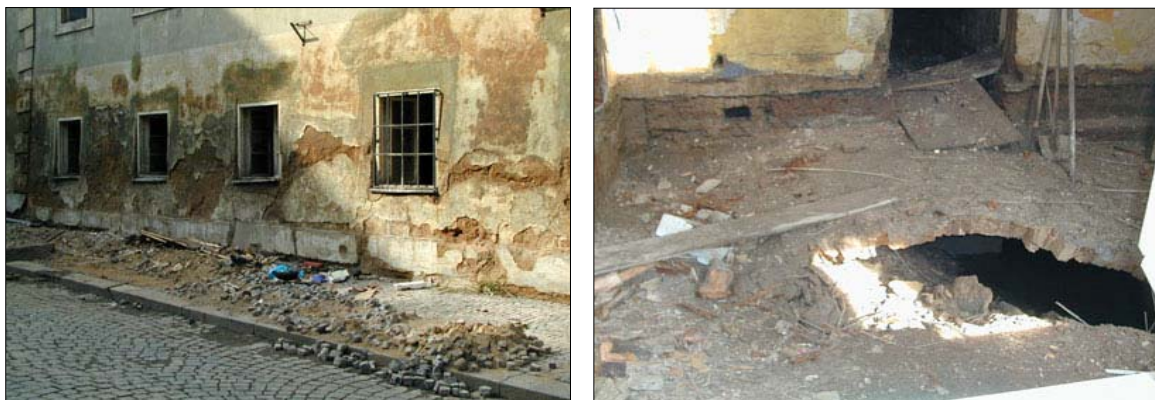
The primary cause of damage in Lesser Town was from above ground flooding and water entry into buildings. Severe damage was observed on outside walls and in the interiors of building basements and first floors (Figure 16). Water marks were plainly visible on the exterior of buildings and some buildings suffered severe masonry damage. Internal damage, such as ruined plaster and holes in the floor, were also common throughout the flooded area.

Figure 17. Severe masonry damage on the outside, and floor collapse inside a building in Lesser Town (photos courtesy of Radio Prague)

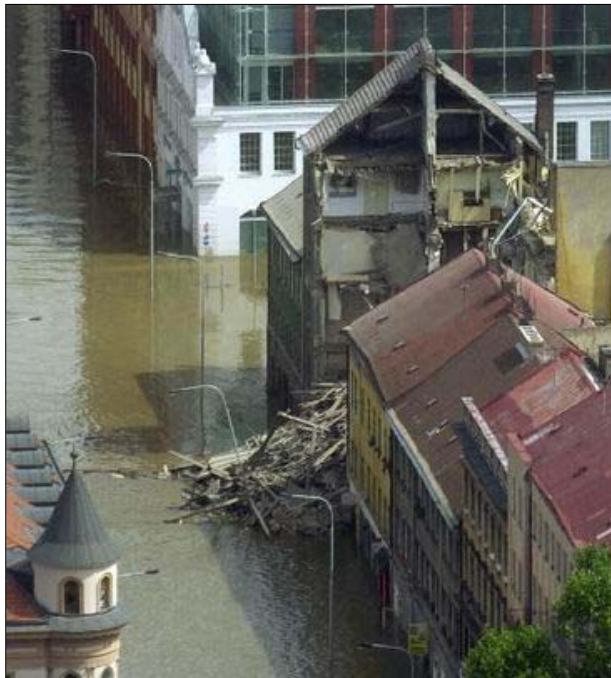
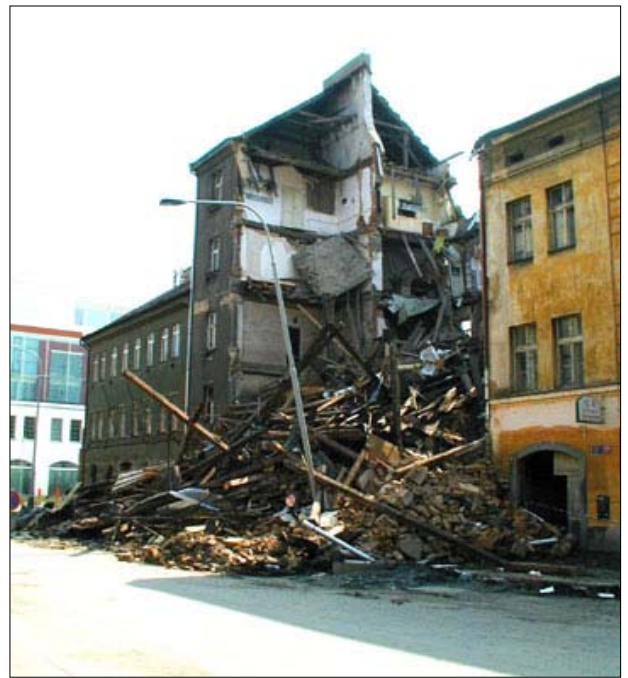
Karlin is located downstream of the Jewish Quarter on the right bank of the Vltava. Built in the 18th century, Karlin was the first suburb outside the original city walls. It is a flat, low elevation, mainly residential district, with multi-story buildings. Floodwaters swamped the district and it suffered some of the worst damage in the city. Water entered buildings from both above and below ground. In total 1,100 buildings were flooded, 43 were condemned and three collapsed (Figure 18).

Figure 18. This multi-story building collapsed whilst the district was still flooded. The complete failure of one part of the building can clearly be seen (photos courtesy of Radio Prague)

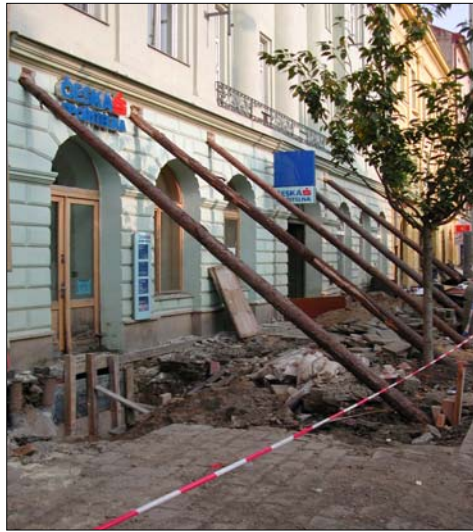
Some buildings settled unevenly as water undermined their foundations and triggered collapses. Karlin's older buildings were particularly susceptible, partly because of the addition of extra stories (and added weight) since their original construction. Localized settling was also visible near several building foundations (Figure 19). Poor soil quality, as reported in this area, also contributed to the failures.

Figure 19. Settling of the pavement soil is evidence that water may have undermined this building. The structure is shored up by temporary supports to prevent collapse

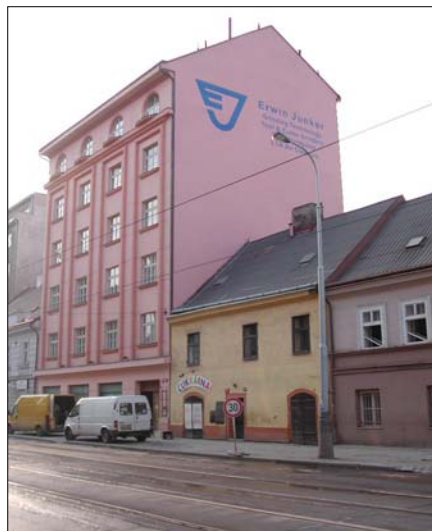
In some rare situations, water levels rose high enough to threaten both the ground floor commercial space and also the residential uses on the second floor. An example is shown in Figure 19, where the water line is visible just below the second story window of the brown building in the center of the photograph. The photograph also illustrates how the percentage of total loss for a structure depended highly on the structure's height and number of stories affected.

Figure 20. Water lines on these structures mark peak flood heights impacting the first two stories of properties in some portions of Karlin
