1959 SUPER TYPHOON VERA: 50-YEAR RETROSPECTIVE

RMS Special Report

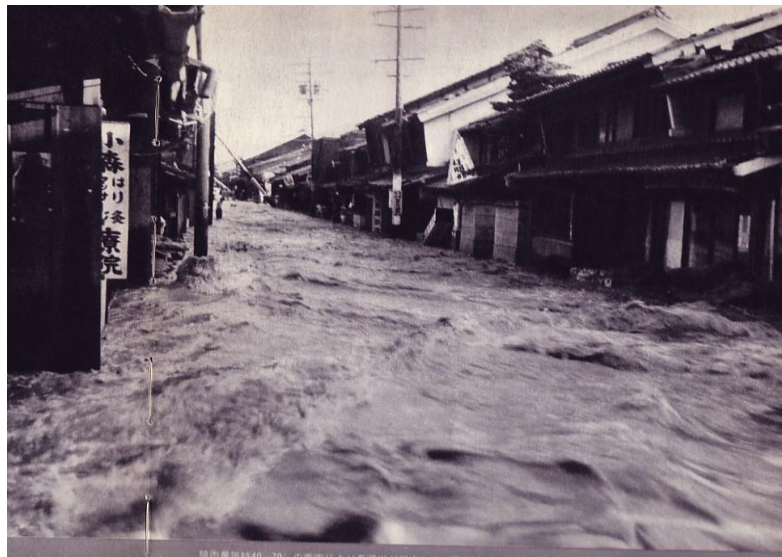
Figure 1: Flooding following Super Typhoon Vera in September 1959 in Nagara Kitamachi, north of Gifu City (Source: http://www.pref.gifu.lg.jp/pref/s11117/saigai_siryu/1959isewan/isewan-2.htm)

The maximum storm surge was close to 13 ft (4 m) above Tokyo Pile (T.P.)³ which inundated defenses along the coastline and flooded low-lying land (Figure 1). The city of Nagoya, which is located on the northern coastline of Ise Bay, was one of the worst hit areas, sustaining heavy flood damage. The inundated areas were difficult to drain, which led to poor sanitary conditions and dysentery infections. Moreover, the effects of the disaster were exacerbated due to the lack of communication. At the time, only around 20-30% of households had television or telephone access, relying instead on radio transmissions as the principal form of communication. Due to the extremely strong winds, telephone and power lines were severed, resulting in only intermittent communication about the impending storm (JWF, 2005).

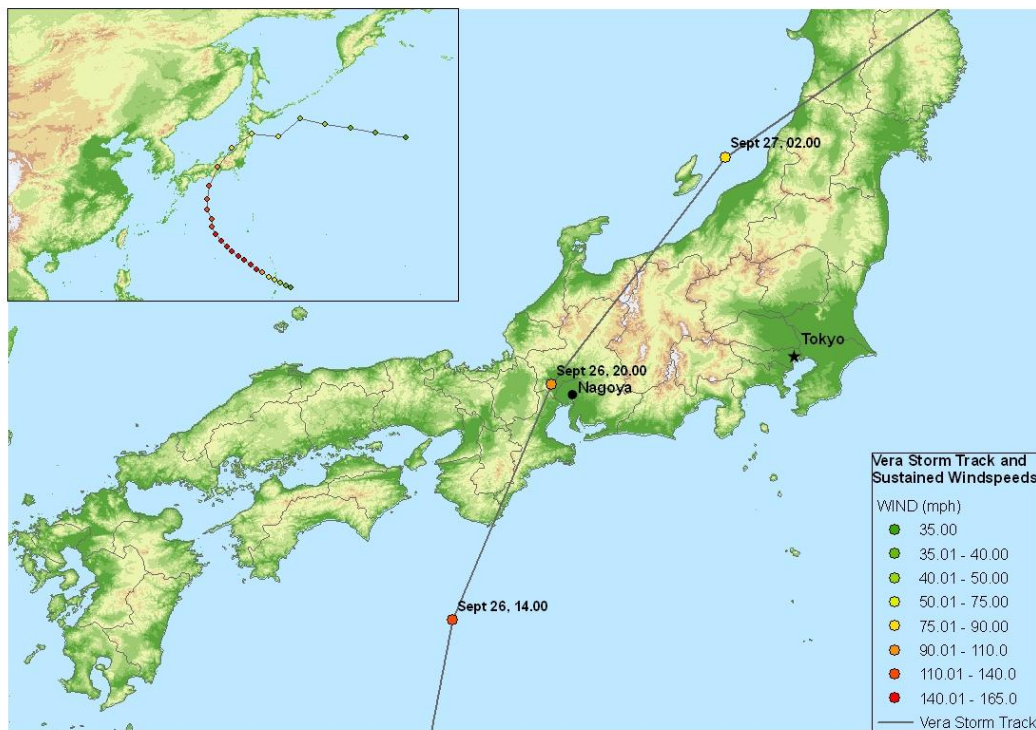
Figure 2: The path of Super Typhoon Vera in September 1959: full path and sustained wind speeds within the Pacific Ocean (upper left) and wind speed times (local time) and path across Japan (main graphic); for example, at 8:00 p.m. local time on September 26, 1959, the storm was just northwest of Nagoya

On September 22, 1959, Vera developed rapidly, with an enormously expanding diameter of 155 mi (250 km) and a quickly decreasing central pressure that reached a maximum low of 896 millibars (mb) (JWF, 2005). Peak winds of 190 mph (306 km/hr) were recorded on September 23, 1959, as the storm developed into a Super Typhoon, measuring as a Category 5 on the Saffir-Simpson Hurricane Scale (i.e., sustained winds greater than 155 mph or 249 km/hr) due to the strong divergence aloft and the continued warm waters of the Pacific Ocean. Beginning on September 23, rain began to fall across the Tokai region on the mainland. The storm remained very strong, only slightly weakening as it continued northward over the next few days (Figure 2). Heavy rainfall preceded the storm, with 4 in (10.4 cm) recorded in the city of Nagoya and nearly 8 in (20 cm) in certain areas of the Mie, Gifu, Aichi, and Shizuoka prefectures from September 23 through September 26 (Tsuchiya and Yasuda, 1980). As the storm progressed, this heavy rainfall caused flooding along various river basins in the region.

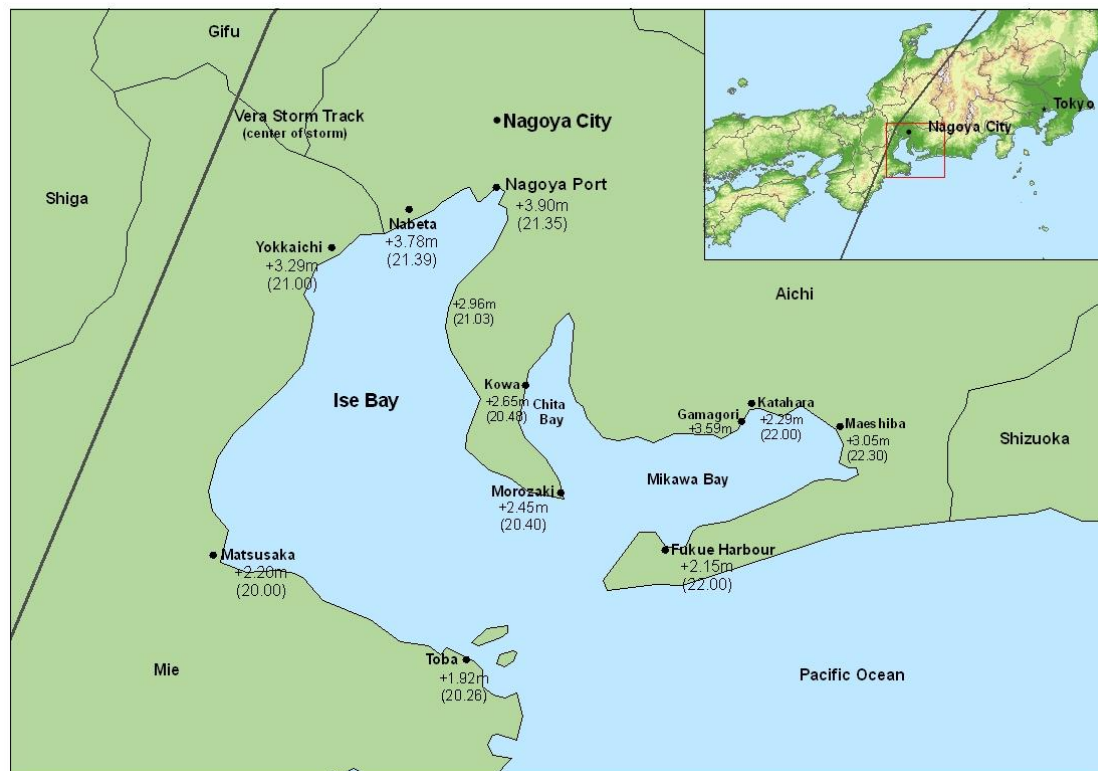
Figure 3: Storm surge levels (measured in meters above Tokyo Pile or T.P.), and times of measurements, around Ise and Mikawa bays on the evening of September 26, 1959 due to Super Typhoon Vera; for example, at the port of Nagoya City, the water level measured 12.8 ft (3.9 m) above T.P. at 9:35 p.m. local time (Source: Tsuchiya and Yasuda, 1980)

across the bay (Figure 3). Maximum storm surge levels (as measured by tide gauge stations) were around 6.6 ft (2 m) above Tokyo Pile (T.P.) at the mouth of the bay, close to 13.1 ft (4 m) above T.P. along the inner part of the bay near Nagoya and 9.8 to 11.5 ft (3 to 3.5 m) above T.P. at the inner part of Mikawa Bay (Tsuchiya and Yasuda, 1980).

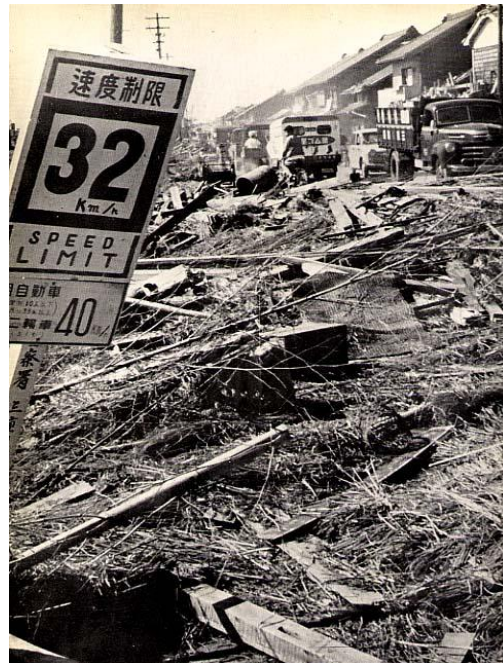
*Figure 6: Wood debris on National Highway 1 following Super Typhoon Vera in September 1959
(Source: <http://ajapskwn.hp.infoseek.co.jp/saigai/p20.html>)*

landfall, Nagoya had approximately 250,000 households. Nearly 50,000 structures collapsed or partially collapsed due to the storm, and approximately 70,000 homes were severely damaged by flood waters. Approximately half of the flooded households were inundated above the first level (e.g., 2 to 3 ft or 0.6 to 0.9 m above the ground), and nearly 1,800 homes were completely washed away (Ishizaki et al., 1961). In Nagoya Harbor, materials from the various industrial facilities were washed away by the heavy rainfall and storm surge, entering the city and further damaging property. In particular, the large amount of floating timber from timber yards blocked roadways (Figure 6), destroyed many buildings, and made rescue efforts extremely difficult.
