# **THE 1999 SYDNEY HAILSTORM: 10-YEAR RETROSPECTIVE**

## **RMS Special Report**

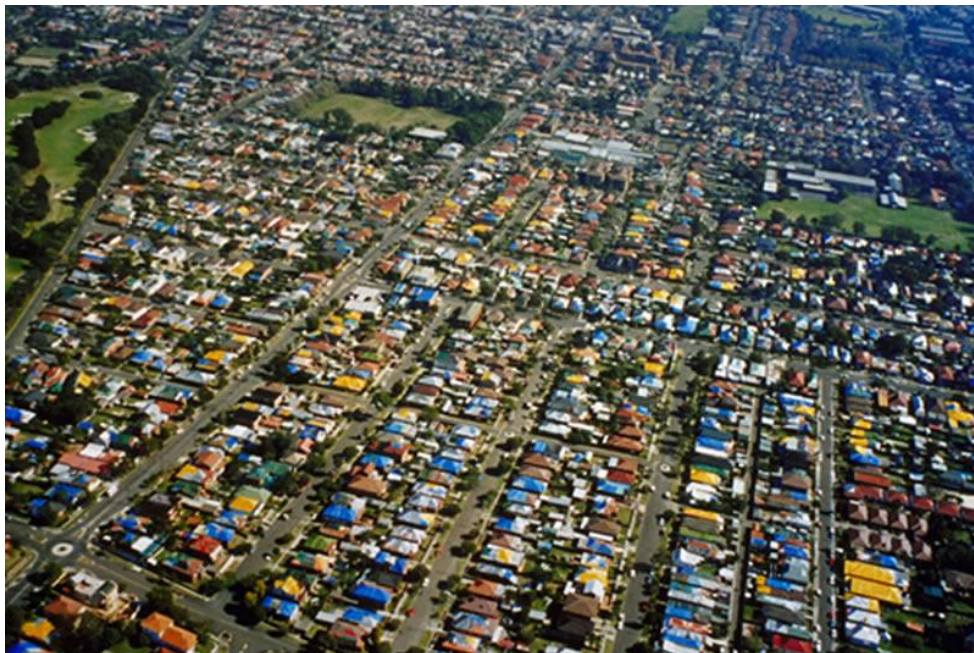
*Figure 1: Blue covers on roofs damaged by hail during the 1999 Sydney Hailstorm (Source: Emergency Management Australia)*

It took up to 2 weeks to cover every damaged roof with tarpaulins to protect the buildings from the elements (Figure 8 and Figure 1). However, further damage was experienced in the subsequent weeks as more strong winds and heavy rains tore away the tarpaulins, allowing more water into the buildings. Many tarpaulins had to be refitted each time they were blown loose by strong winds, multiplying the workload of the emergency responders.

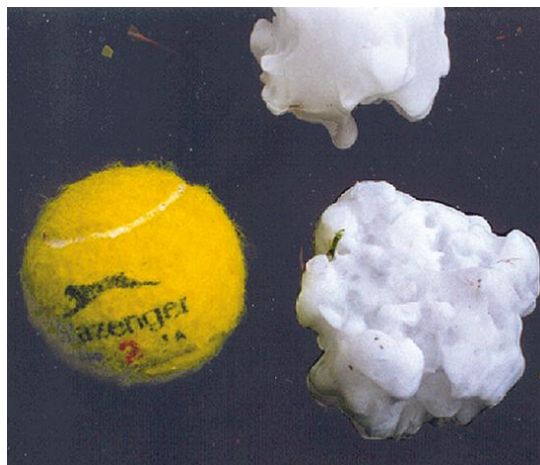
*Figure 3: Hailstones from the 1999 Sydney Hailstorm, alongside a tennis ball, illustrating the large size of the hailstones (Source: Australian Science and Technology Heritage Centre)*

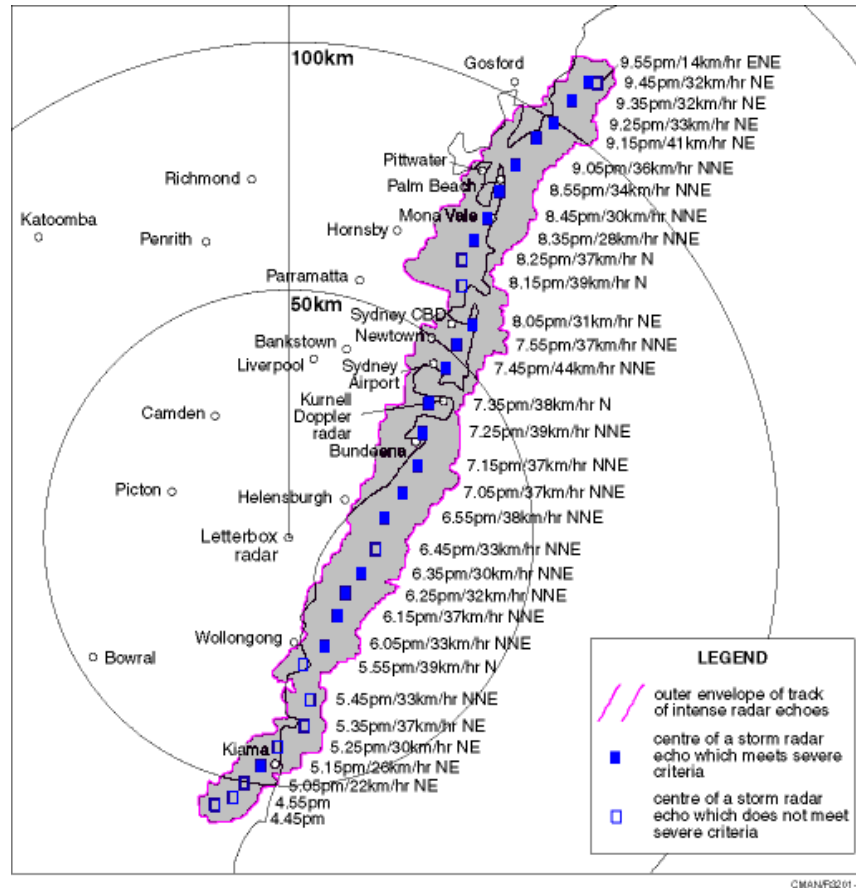
Figure 4: Track of the 1999 Sydney Hailstorm, derived from radar data; location, speed, and direction of the storm are shown at 10-minute intervals, starting at 4:45 p.m. and ending at 9:55 p.m. local time on April 14, 1999 (Source: Bureau of Meteorology, 2009b)

toward the coast. Approximately 50 minutes later, at 5:05 p.m., the storm matured into a severe thunderstorm as it tracked just west of Kiama, traveling at 26 km/hr (16 mph) and dropping significant amounts of hail. Ten minutes later, at approximately 5:25 p.m., the storm reached the NSW coast, gaining speed as it moved farther from the coast. The storm was expected to continue tracking northeast out to sea, where it was forecast to dissipate.

However, at 5:45 p.m., the storm, which was still largely offshore, changed direction to a north-northeast (NNE) track, re-intensifying as it tracked parallel to the coast. The storm's western edge reached Wollongong around 6:05 p.m. as a severe thunderstorm. The storm then tracked parallel to the coast in a NNE direction for the next 70 minutes, until the storm's center neared land again around 7:15 p.m. just to the east of Bundeena, traveling at a speed of 37 km/hr (23 mph). Over the next hour and thirty minutes, the severe thunderstorm tracked across the coastal and eastern suburbs of Sydney, tracking east of the Sydney Airport around 7:45 p.m. (Figure 4), weakening briefly after crossing the Sydney Harbour and shifted to track due north. The storm re-intensified just south of Mona Vale around 8:35 p.m., changing back to its more prominent direction of NNE.

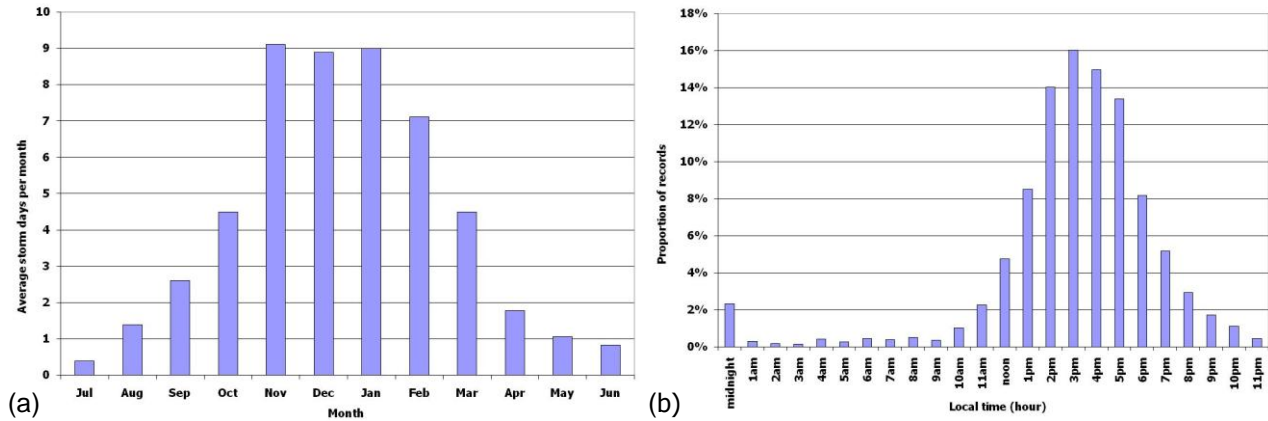
Figure 5: Distribution of severe convective storms in NSW: (a) on a monthly basis (i.e., average storm days per month) and (b) on an hourly basis (i.e., as a proportion of all records). Note that the spike at midnight is associated with a default for an uncertain, overnight time in the BoM severe storm database.

While it is possible for severe convective storms in New South Wales to occur at any time of year, the required meteorological conditions and favorable weather patterns for severe convective storm development occur more frequently in the warmer spring and summer months. An analysis of severe thunderstorm days in New South Wales from 1989 to 2006 illustrates this seasonality, showing a tendency for severe thunderstorms to occur during the months September through to March (Figure 5(a)). There is also a tendency for severe thunderstorms to occur in the afternoon, when the daily heating of the Earth’s surface by the sun is at a maximum (Figure 5(b)).

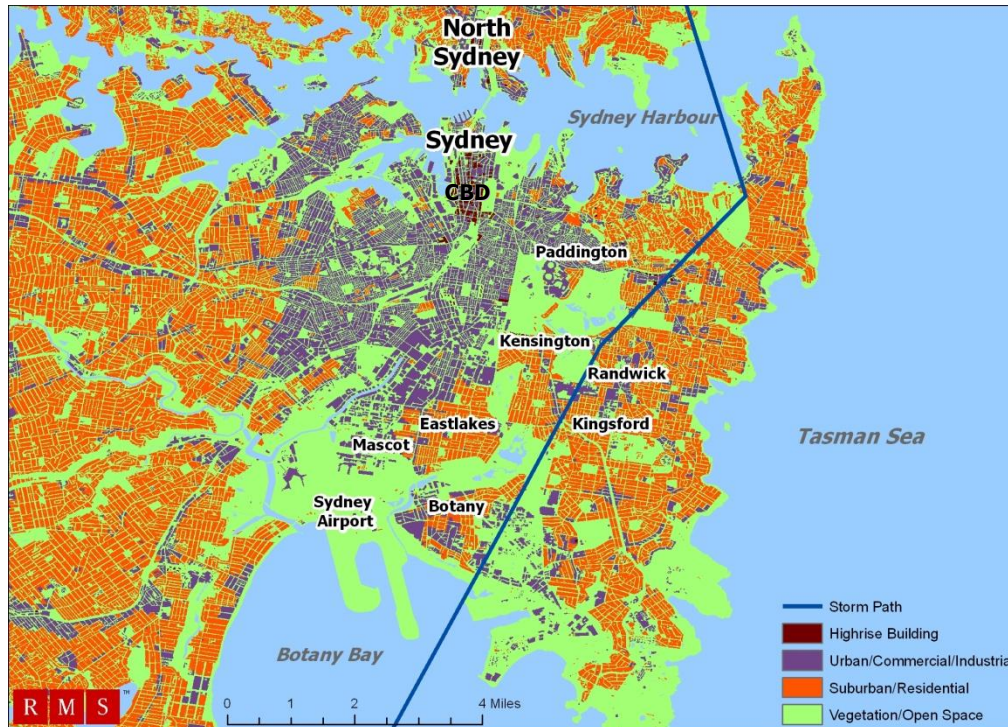
Figure 6: Map illustrating the concentration of exposure in Sydney and the worst-affected suburbs, with the path of the 1999 Sydney Hailstorm highlighted

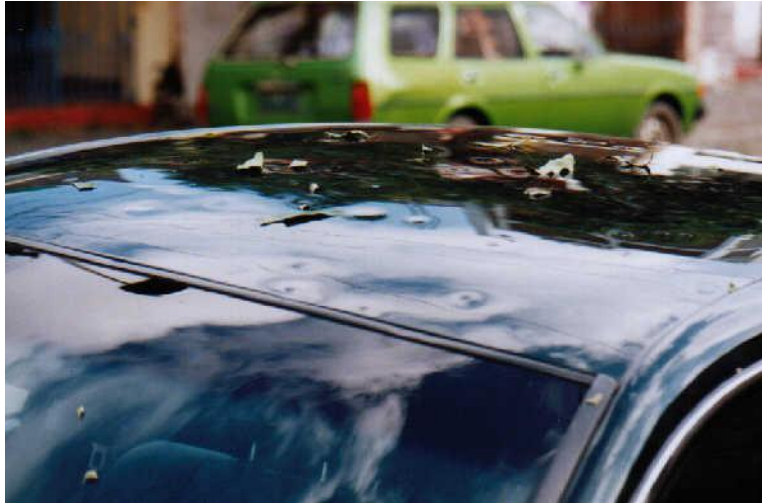
Many vehicles suffered broken windshields and dents to the bodywork (Figure 7), and several motorists became trapped by floodwaters.

*Figure 7: Damage to a car roof as a result of the 1999 Sydney Hailstorm (Source: <http://ozthunder.com/chase/chase13.htm>)*

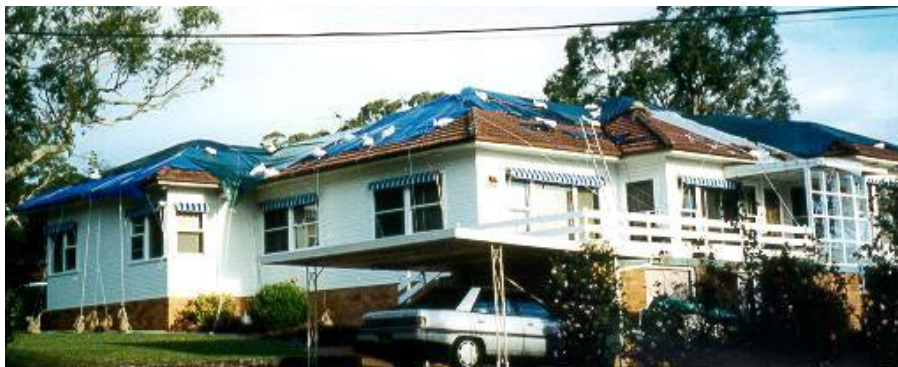
*Figure 8: Tarpaulins covering the roof of a residential structure in the eastern suburbs of Sydney following the 1999 Sydney Hailstorm (Source: <http://willoughby.ses.nsw.gov.au/Hail.html>)*

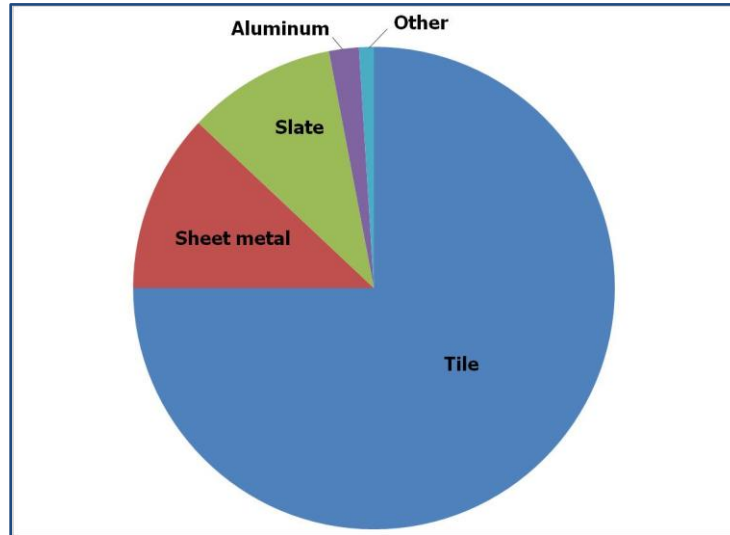
During the 1999 Sydney Hailstorm, 70% of damaged roofs were constructed of terra-cotta tiles, with another 5% constructed of slate tiles and the remainder constructed with other types of roofing materials (e.g., concrete tiles, metal roofs). At the time of the storm, the majority of damaged homes were built before the 1930s with the predominant roofing material being terra-cotta tiles. Since this time, the majority of residential structures in NSW have continued to be built with terra-cotta roofing tiles (Housing Industry Australia, 2006). As illustrated in Figure 9, approximately 75% of new homes in 2006 were constructed with tiled roofs, with an additional 12% of the roofs constructed using sheet metal and 10% of roofing using slate tile.

Figure 9: Distribution of roof type for new construction in New South Wales, based on 2006 data (Source: Housing Industry Australia, 2006)

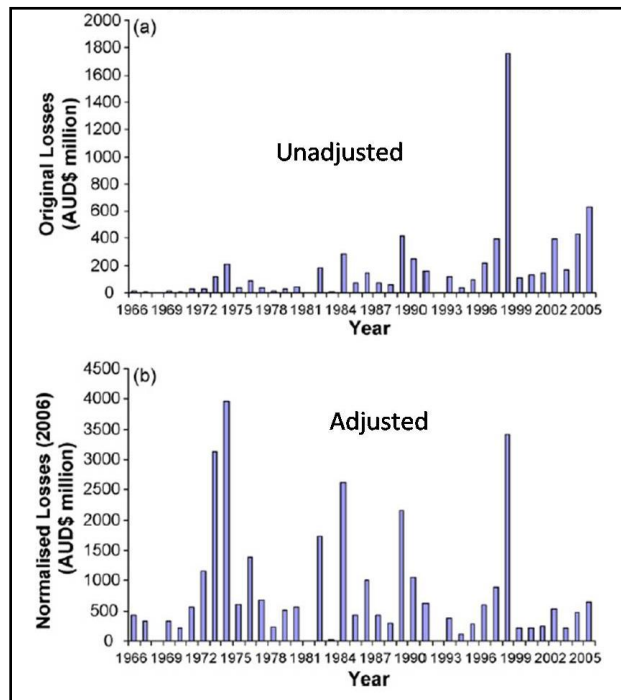
Figure 10: Australian insured losses from meteorological hazards (1967–2006) at the time of occurrence (above) and normalized to 2006 dollars (below) (Source: Crompton and McAneney, 2006)

If one considers population, inflation and wealth adjustments, the insured loss from the 1999 Sydney Hailstorm is AUD\$3.3 billion, ranking third behind a normalized loss of AUD\$3.65 for Cyclone Tracy in 1974 and AUD\$4.3 billion for the 1989 Newcastle Earthquake (Table 3). The top 10 adjusted losses from 1967 through 2006, based on the work by Crompton and McAneney (2006) are illustrated in Figure 10.
