# **THE 1999 SYDNEY HAILSTORM: 10-YEAR RETROSPECTIVE**

## **RMS Special Report**

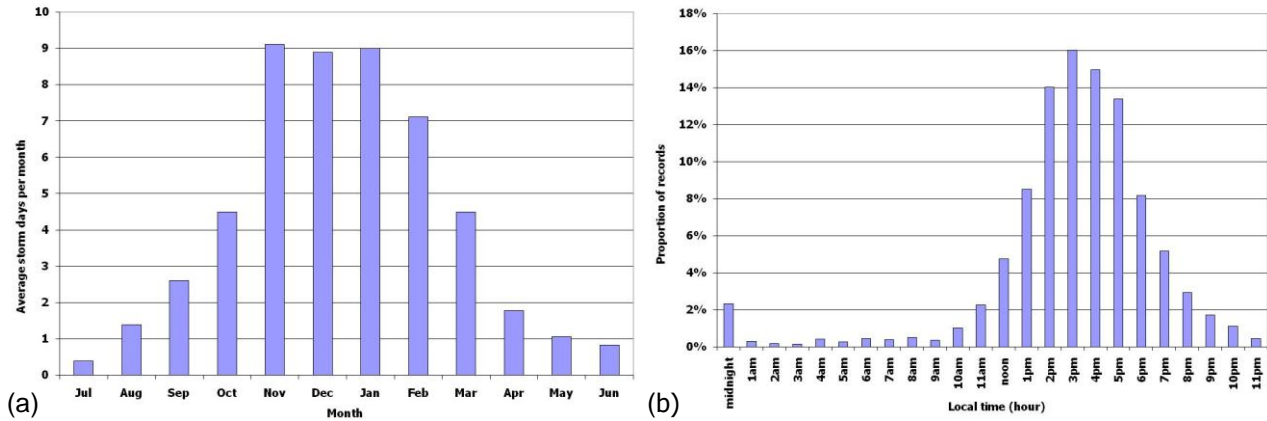
Figure 5: Distribution of severe convective storms in NSW: (a) on a monthly basis (i.e., average storm days per month) and (b) on an hourly basis (i.e., as a proportion of all records). Note that the spike at midnight is associated with a default for an uncertain, overnight time in the BoM severe storm database.

While it is possible for severe convective storms in New South Wales to occur at any time of year, the required meteorological conditions and favorable weather patterns for severe convective storm development occur more frequently in the warmer spring and summer months. An analysis of severe thunderstorm days in New South Wales from 1989 to 2006 illustrates this seasonality, showing a tendency for severe thunderstorms to occur during the months September through to March (Figure 5(a)). There is also a tendency for severe thunderstorms to occur in the afternoon, when the daily heating of the Earth's surface by the sun is at a maximum (Figure 5(b)).

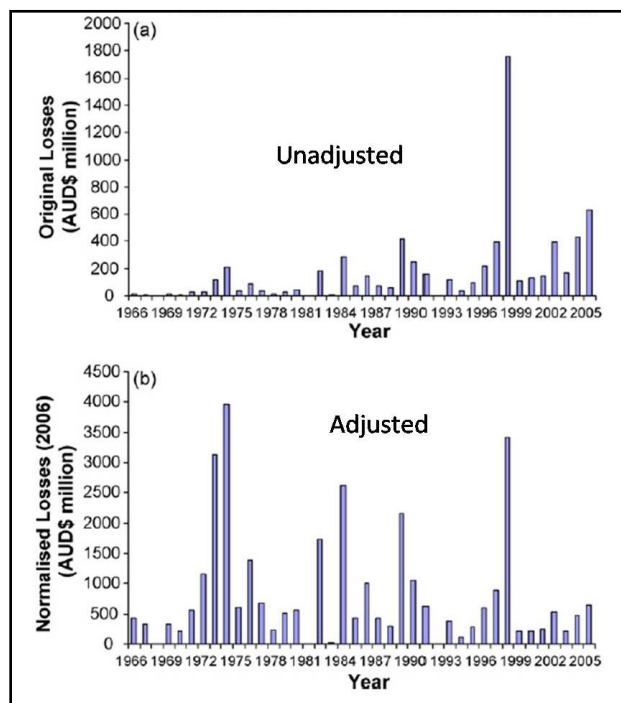
Figure 10: Australian insured losses from meteorological hazards (1967–2006) at the time of occurrence (above) and normalized to 2006 dollars (below) (Source: Crompton and McAneney, 2006)

If one considers population, inflation and wealth adjustments, the insured loss from the 1999 Sydney Hailstorm is AUD\$3.3 billion, ranking third behind a normalized loss of AUD\$3.65 for Cyclone Tracy in 1974 and AUD\$4.3 billion for the 1989 Newcastle Earthquake (Table 3). The top 10 adjusted losses from 1967 through 2006, based on the work by Crompton and McAneney (2006) are illustrated in Figure 10.
